MMPF0100 Errata for Mask 1N47F and 1N18J

This errata document applies to the mask 1N47F, 1N18J SMARTMOS devices.

Document Number: MMPF0100ER
Rev. 5.0
4/2014

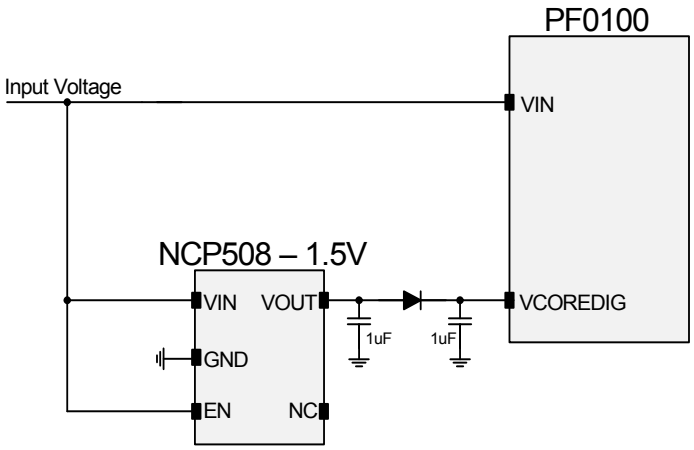
<table><tr><th>Errata No.</th><th>Erratum</th><th>Customer Impact</th><th>Description</th></tr><tr><td colspan="3"> 
Figure 1. Workaround for ER19</td></tr></table>

<table><tr><th>Errata No.</th><th>Erratum</th><th>Customer Impact</th><th>Description</th></tr><tr><td rowspan="2">ER19</td><td>Startup:
False start and/or non-start of regulators</td><td>When VIN starts, it ramps up from between 100 mV and 400 mV, the regulators may not startup and/or the buck regulator outputs can glitch high momentarily.</td><td>Description:
In applications without a valid voltage on the LICELL pin, when VIN starts its ramp from between 100 mV and 400 mV, there can be two failure symptoms:
1 Fuses may not load during startup for systems with VDDOTP = 0 V (OTP configuration) resulting in non-start of all PF0100 regulators.
2 During VIN ramp up, the top P-MOSFET of buck regulators may turn on while 1.0 V ≤ V_{IN} ≤ 2.1 V. For VIN rise times less than 10 ms, buck regulator outputs can rise up to 1.0 V as VIN transitions from 1.0 V to 2.1 V. For VIN rise times greater than 10 ms, buck regulator outputs can rise up to 2.1 V as VIN transitions from 1.0 V to 2.1 V.
Workaround:
The workaround consists of external components. Refer to Figure 1.
• LDO: 1.3 V to 1.5 V LDO. NCP508 or similar. The LDO should have an enable threshold of 0.9 V or lesser and a turn on time in the order of 10 μs.
• Diode: BAS116 or similar. Diode is not required if no coin cell is present at LICELL. Only one 1.0 μF is required if no diode if used.
Notes:
1. Previously SIP21106, LX8211, MIC5205 or similar LDOs were suggested as workaround. While these will prevent symptom 1) mentioned above, they may not prevent symptom 2) since their enable threshold is above 1.0 V.
Applies to:
PF0100
Fix Plan/Status
Fixed on PF0100A</td></tr></table>
